**DEFENDANT STATE FARM FIRE AND  
CASUALTY COMPANY'S EXPERT  
DISCLOSURE**

**NORRIS PIPE AND SOIL DAMAGE INVESTIGATION**

**NORRIS DAMAGE REPAIR COST ALLOCATION**

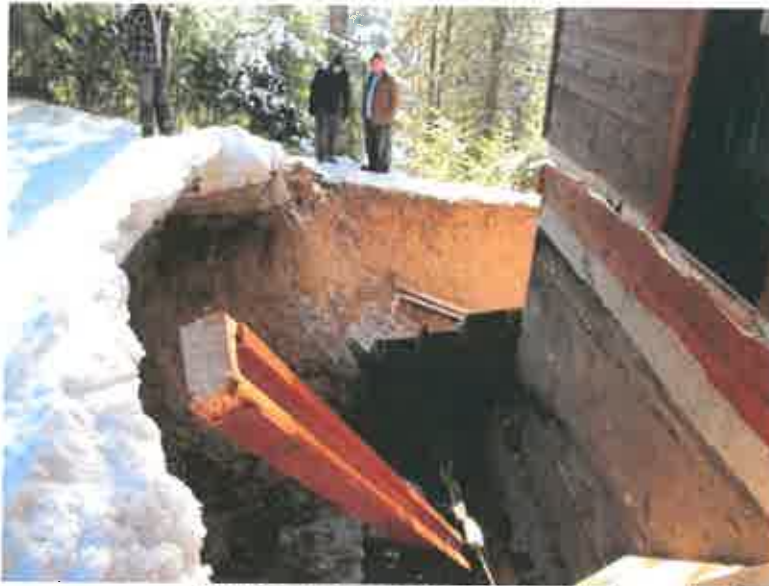
The soils beneath the footings of the elevated exterior deck at the east and south sides of the house had been displaced, resulting in the downward displacement of the decks. A portion of slab on grade concrete patio at the south side of the house was also displaced downslope. (Photographs 1 - 3)

**Photograph 1 - Erosion damage at the southeast corner of the house, looking south**

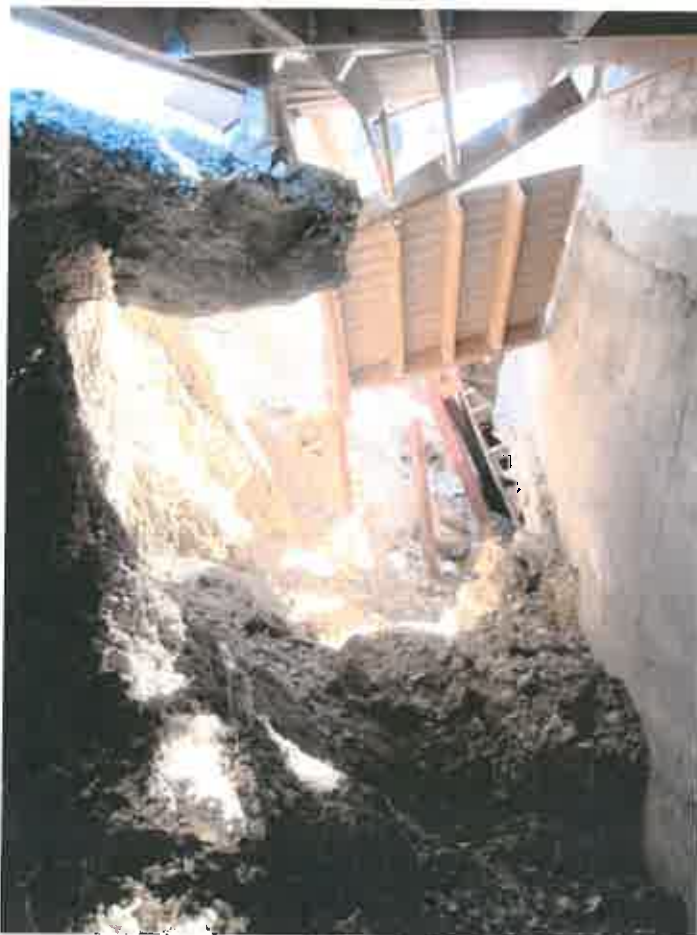
**Photograph 2 – Erosion damage at the east side of the house, looking south**

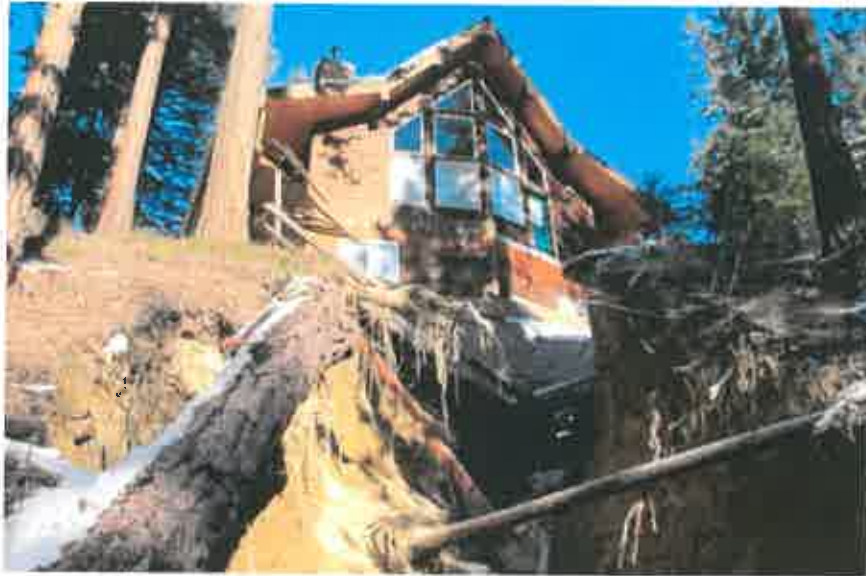
**Photograph 3 – Erosion damage at the south side of the house**

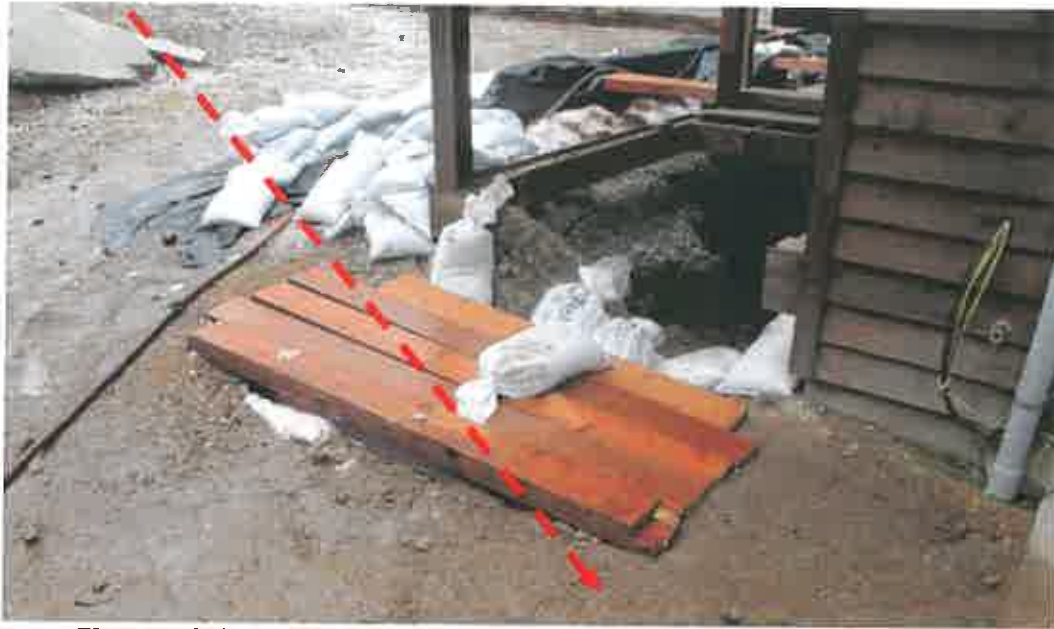
CASE performed a second site examination on December 30, 2013. An excavated pit measuring approximately 4 by 4 by 4 feet deep was observed at the northeast corner of the house. The excavated pit was protected by 2x lumber and fiberglass insulation. Photograph 4 indicates the location of the pit relative to the northeast corner of the house. The red dashed line indicates the approximate orientation of the domestic water supply line from the valve box to the house.

**Photograph 4 – Location of pipe fitting failure at the northeast corner of the house**

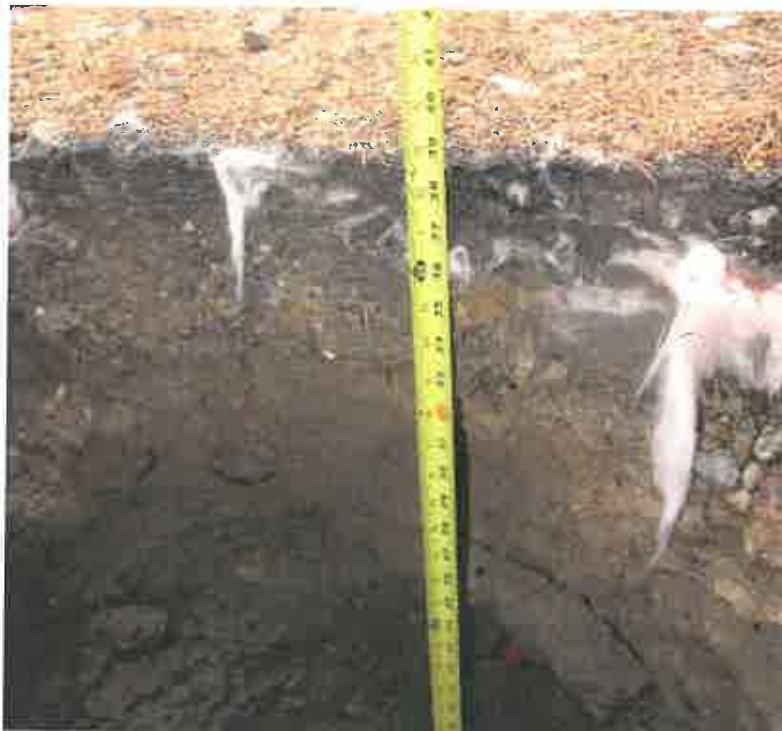
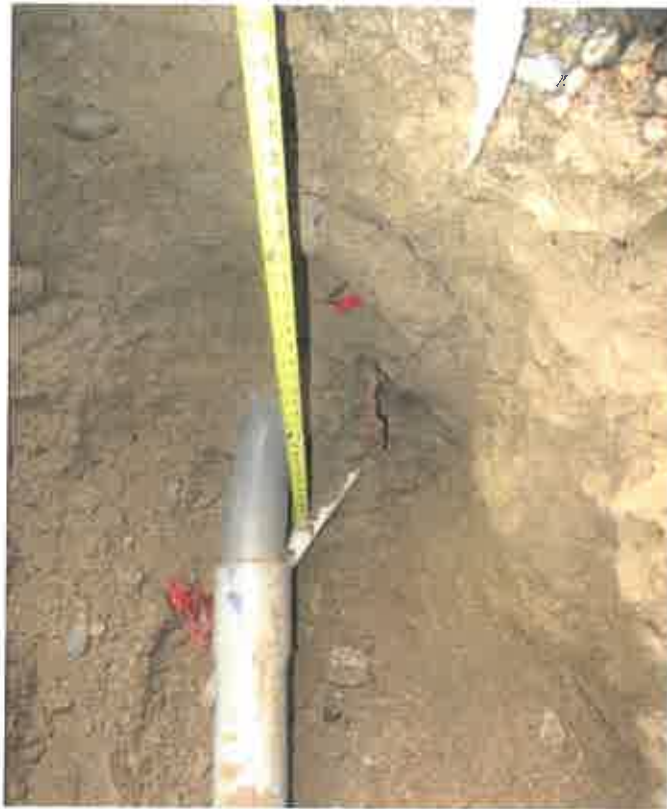
Within the excavated pit, the 1 inch PVC water supply line was observed oriented in a generally east-west direction. The PVC pipe was located approximately 3 inches beneath an approximately 3 inch diameter plastic electrical conduit (Photographs 5, 6)

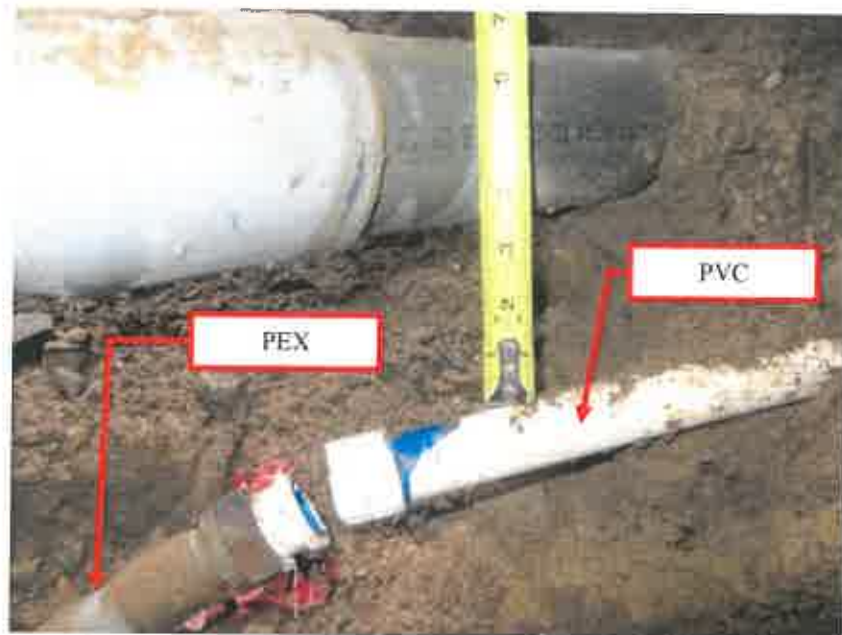
A failed PVC fitting was observed at a joint between the PVC water supply pipe and the PEX tubing that continues eastward toward the house. (Photograph 7) The bury depth of the pipe at the location of the failed fitting was measured to be 40 inches below grade.

**Photograph 7 – Failed fitting of water supply pipe, looking north**

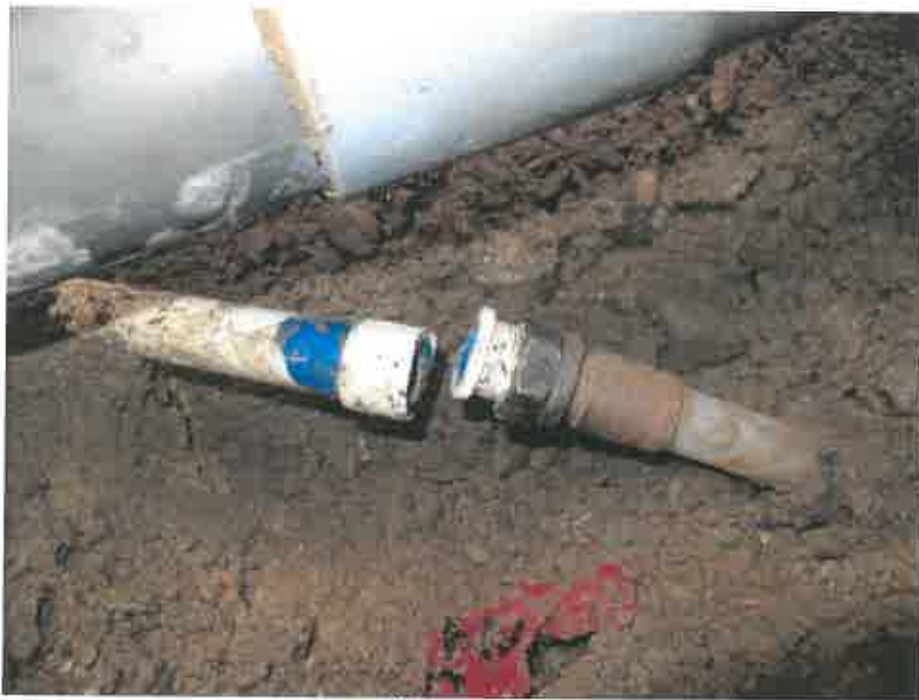
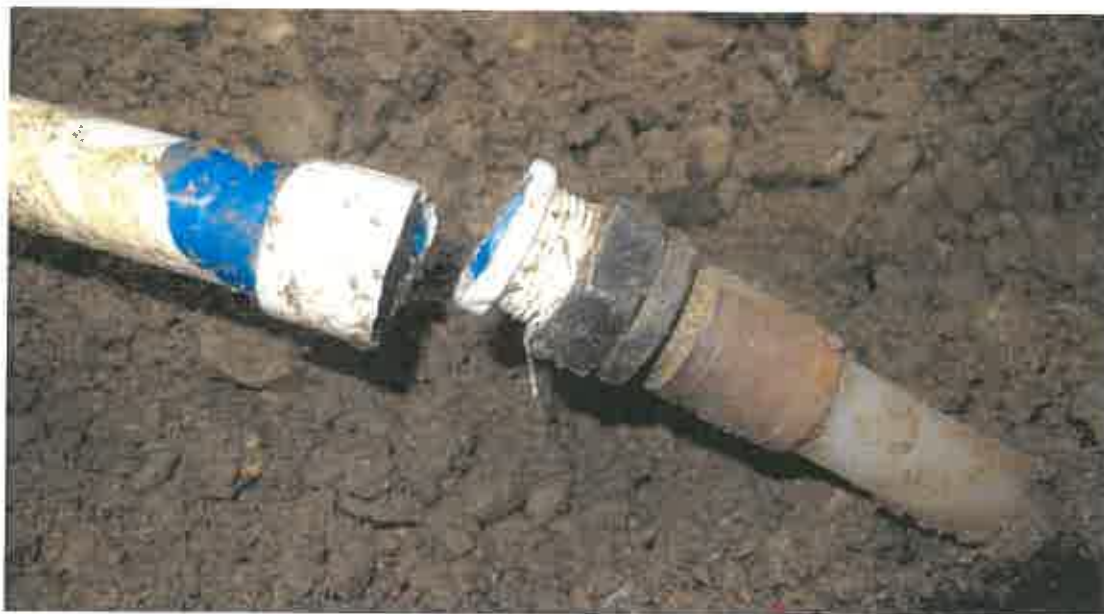
Observation revealed the domestic water supply pipe was not oriented in a straight line. An upward bend in the pipe was observed at the joint between the PVC and PEX tubing. Hand manipulation of the pipe segments indicated a tendency for the pipe ends to “spring” upward when released. (Photographs 8, 9)

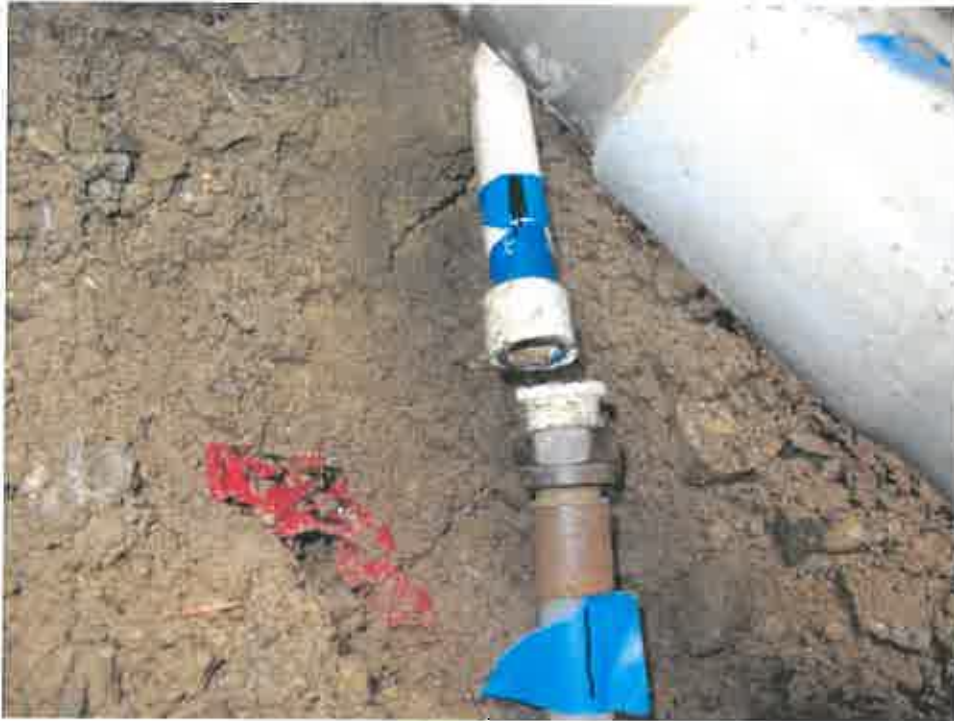
**Photograph 10**

The PVC pipe and PEX tubing were both marked to indicate the upward facing surfaces and were subsequently cut to remove the two component halves of the failed PVC fitting. The samples were labeled and were taken into custody as evidence for additional laboratory examination by Warren Harris, Senior Forensic Chemist with CASE. (Photograph 10)

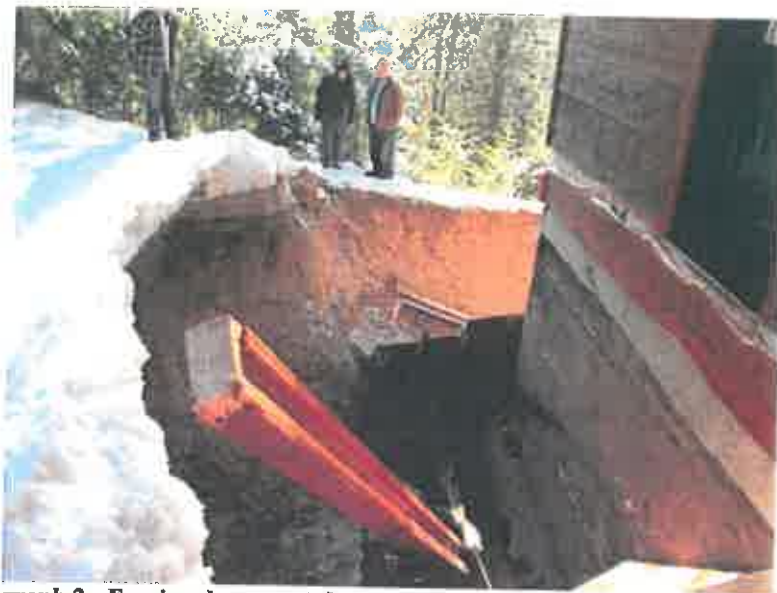
31. Site conditions were clear and approximately 18°F. There was up to 12 inches of accumulated snow on the ground, which was frozen. Hand excavation and/or probing of the soils adjacent to the house was not possible due to the cold conditions.
32. A large quantity of the backfilled soils along the south 2/3 of the west side of the house and across the width of the south side of the house had been displaced downslope and to the south, toward the Wenatchee River. (Figure 1)
33. The soils beneath the footings of the elevated exterior decks at the east and south sides of the house had been displaced, resulting in the downward displacement of the decks. A portion of slab on grade concrete patio at the south side of the house was also during displaced downslope. (Photographs 2-4)

**Photograph 2 - Erosion damage at the southeast corner of the house, looking south**

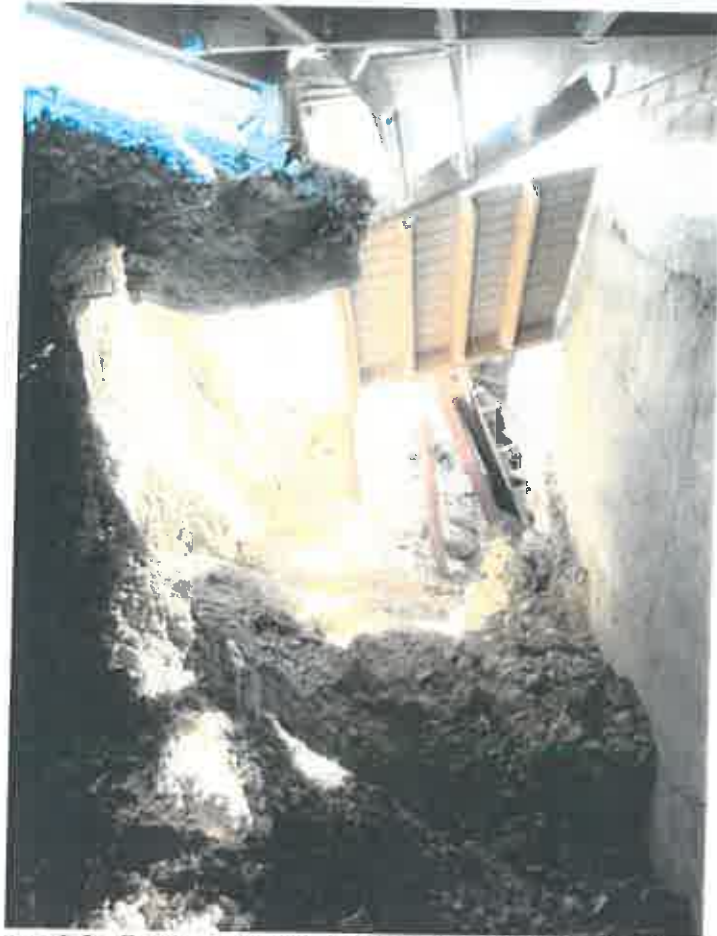
**Photograph 3 – Erosion damage at the east side of the house, looking south**

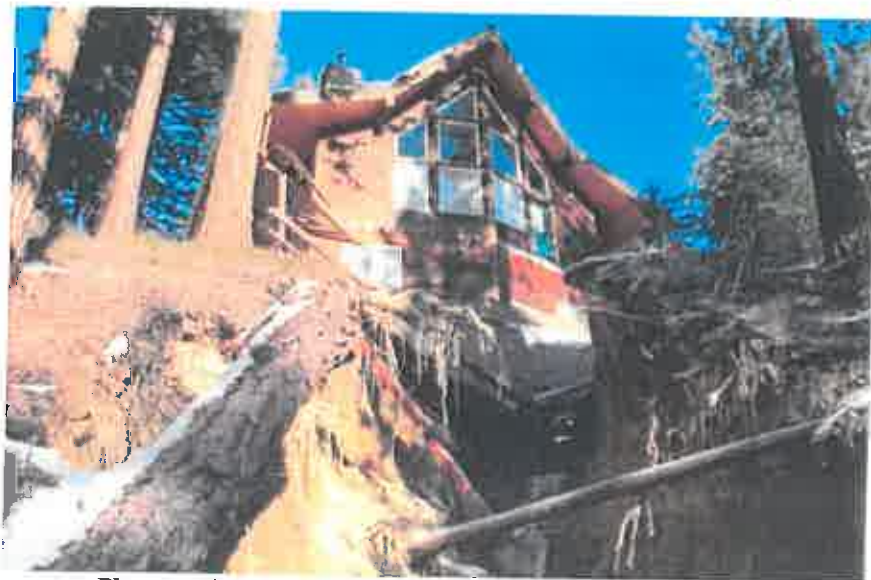
**Photograph 4 – Erosion damage at the south side of the house**

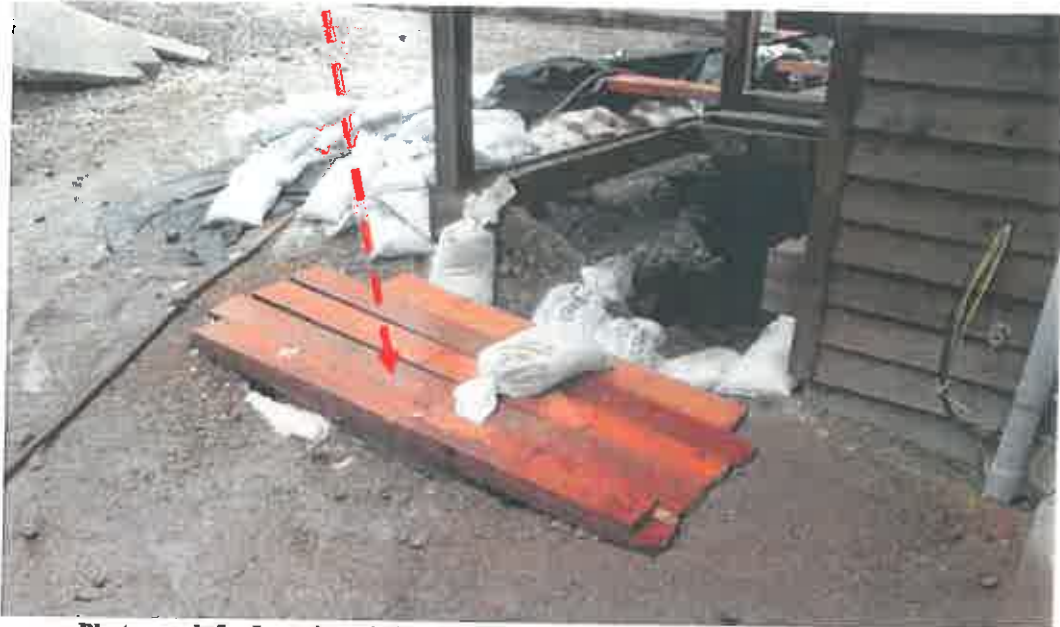
36. An excavated pit measuring approximately 4 by 4 by 4 feet deep was observed at the northeast corner of the house. The red dashed line indicates the approximate orientation of the domestic water supply line. (Photograph 5)

**Photograph 5 – Location of pipe fitting failure at the southeast corner of the house**

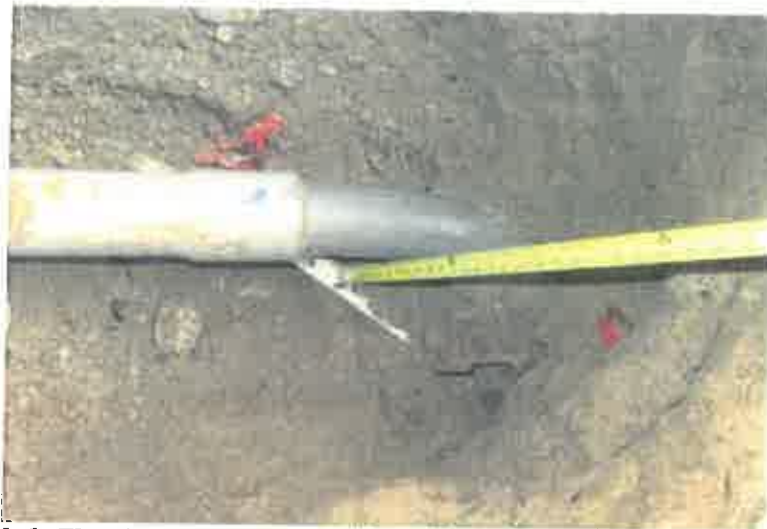
37. Within the excavated pit, the 1 inch PVC water supply line was observed oriented in a generally east-west direction. The elevation of the pipe was measured to be 3'-4" below grade. The PVC pipe was located approximately 3 inches beneath an approximately 3 inch diameter plastic electrical conduit. (Photographs 6 and 7)

**Photograph 6 - Electrical conduit (top) and domestic water supply pipe, looking downward**

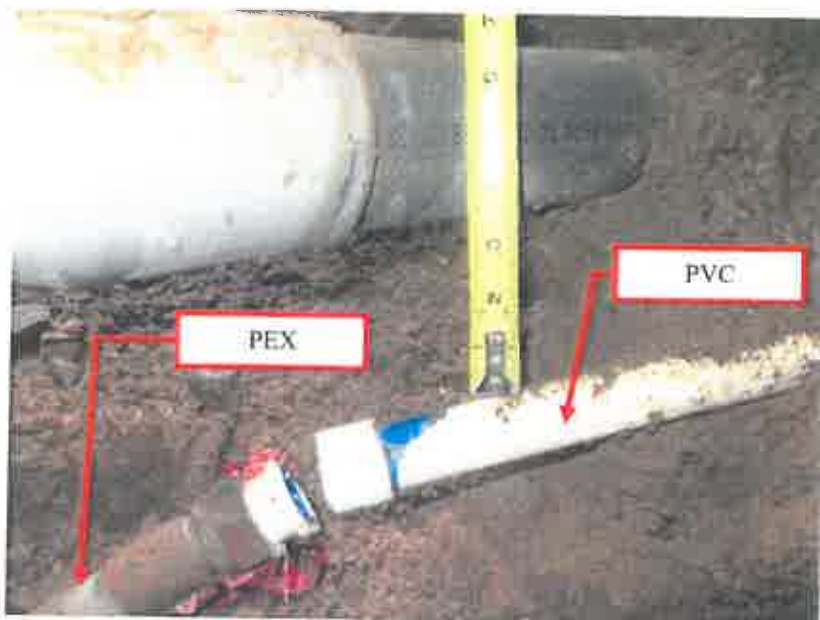
**Photograph 7 – Failed fitting of water supply pipe, looking north**

38. A failed PVC fitting was observed at a joint between the PVC water supply pipe and the PEX tubing that continues toward the house. (Photograph 7)
39. Observation revealed the domestic water supply pipe was not installed in a straight line. An upward bend in the pipe was observed at the joint between the PVC and PEX tubing. Hand manipulation of the pipe segments indicated a tendency for the pipe ends to “spring” upward when released.

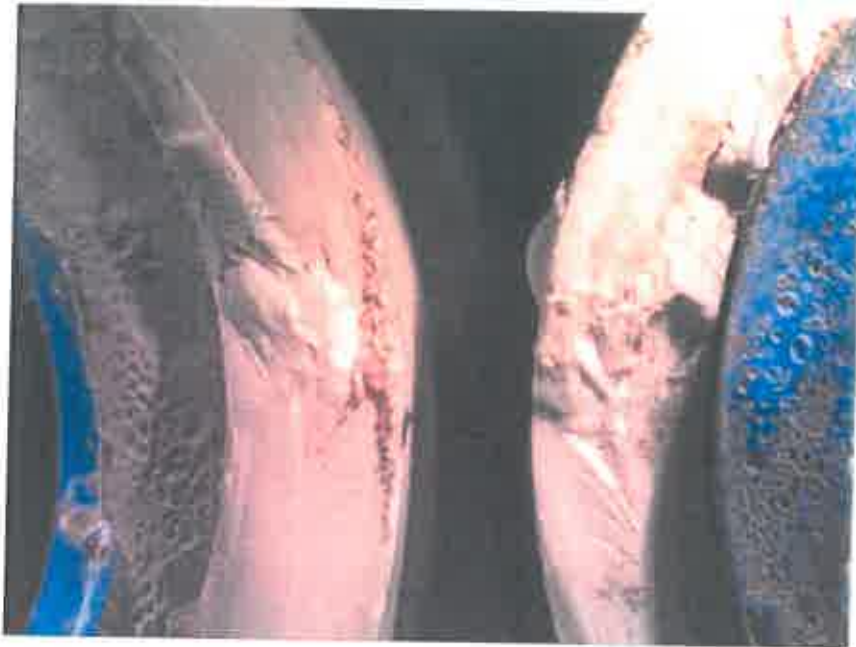
scour suggest that the fracture initiated as a fine hairline crack at the upper most portion of the pipe and a long term spraying of water from the crack churned the sand grains in the backfill so as to create the scour pattern on the upper surface of the pipe. Furthermore, it is likely that the long term spraying and scour event resulted in the slow removal of the back-fill overburden such that the existing coil stress on the PEX tubing exceeded the remaining strength in the PVC threaded joint.

46. No evidence of tool marks or improper cementing of the threaded PVC union was found. The drip patterns from excess cement on pie/union join reveal the PVC pipe was in a horizontal position when the PVC union was cemented.
47. The exposed fracture surface that was not scoured exhibits evidence of both a rapid brittle fracture and a slow tearing ductile fracture. (Photograph 8)
48. The forces associated with the formation of the initial hairline fracture in the PVC threaded union were created at the time the PVC was joined with the PEX. It is also likely that the fracture was initiated at the time of installation.

**Photograph 8 – Microscope image of component parts of failed PVC fitting**
